K.M.Eazhil AP/Mech/SNSCE PEHV

THE CHALLENGER DISASTER A CASE-STUDY IN ENGINEERING ETHICS

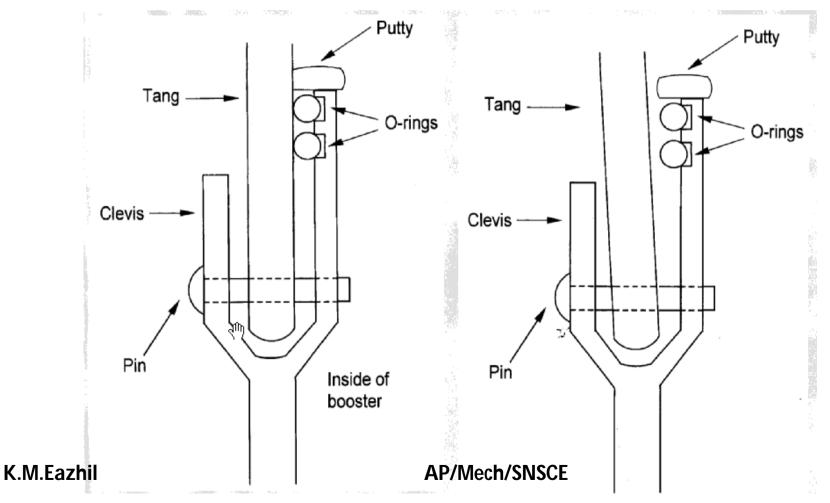
THE CAUSE OF THE DISASTER

- Inability of the O-rings to expand and seal at low temperatures.
- Heat shield putty did not perform at low temperatures
- •Fits and seating of the O-ring was affected by low temperature.
